## **Could Your Balcony Balustrades be Ladders to Litigation?**

### **How To Stop Rising Injury Claims - Slips, Trips & Falls**

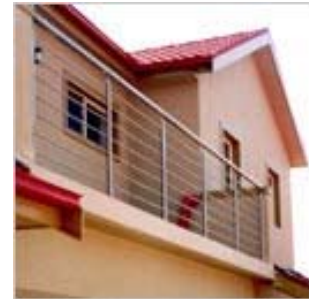
Your balustrades could be below the legal height, have openings that are too wide or have horizontal members that act as a ladder.

Balconies with stainless steel wire, thin metal or wooden slats running horizontally can be a cause for concern.

- The top of the railing must be at least 1 metre (1000mm) from the ground
- Any opening must not permit a 125mm sphere to pass through it - this includes both horizontal and vertical railings
- For balcony floors more than 4 metres off the ground floor there must not be any horizontal or near horizontal elements that facilitate climbing between 150mm and 760mm above the floor
